SpaceShip Two: The Anatomy of a Commercial Space Accident

In-Flight Breakup During Test Flight

October 31, 2014

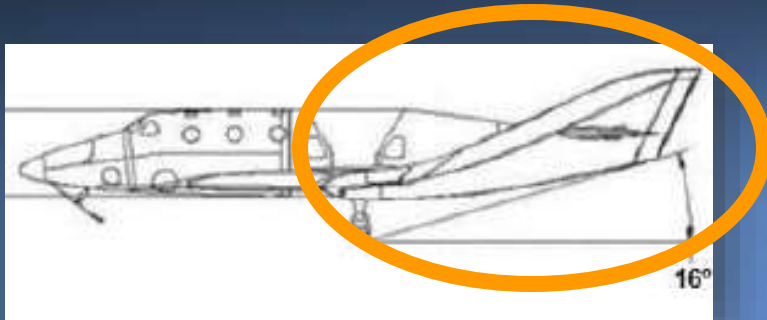
Feather retracted

PROBLEM: During the transonic region, the upward aerodynamic forces acting on the feather exceeded the ability of the feather actuators to keep the feather retracted.

SOLUTION:
Provide
mechanical
locks to keep
feather
retracted during
this region.

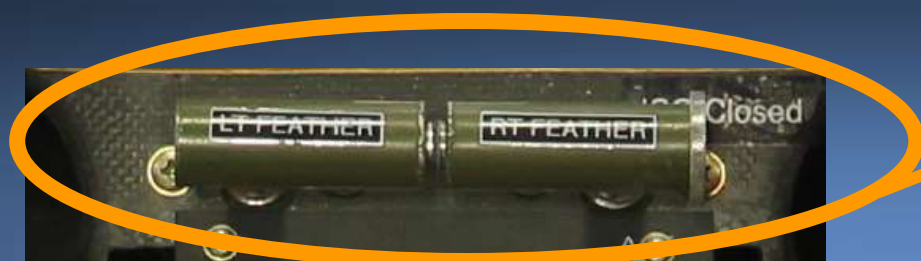
Feather extend handle

- Copilot made 0.8 Mach callout
- At 0.82 Mach, called out “unlocking” and moved feather handle to unlocked position
- Video and telemetry stopped

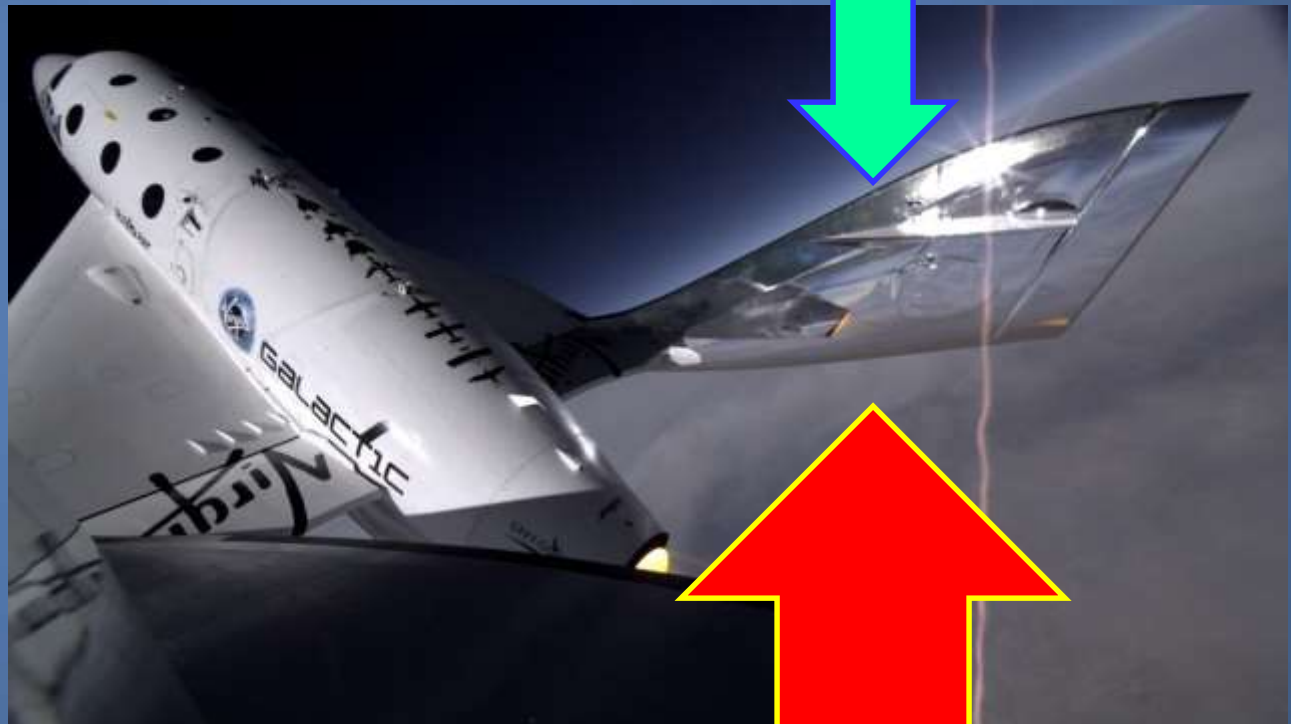
Feather Lock Handle

PROBLEM: If feather could not be unlocked, it would pose a very high risk (probably catastrophic) reentry.

SOLUTION: Unlock feather at 1.4 Mach.

If not unlocked at 1.5 Mach, cockpit alert.
If not unlocked at 1.8 Mach, mission abort.

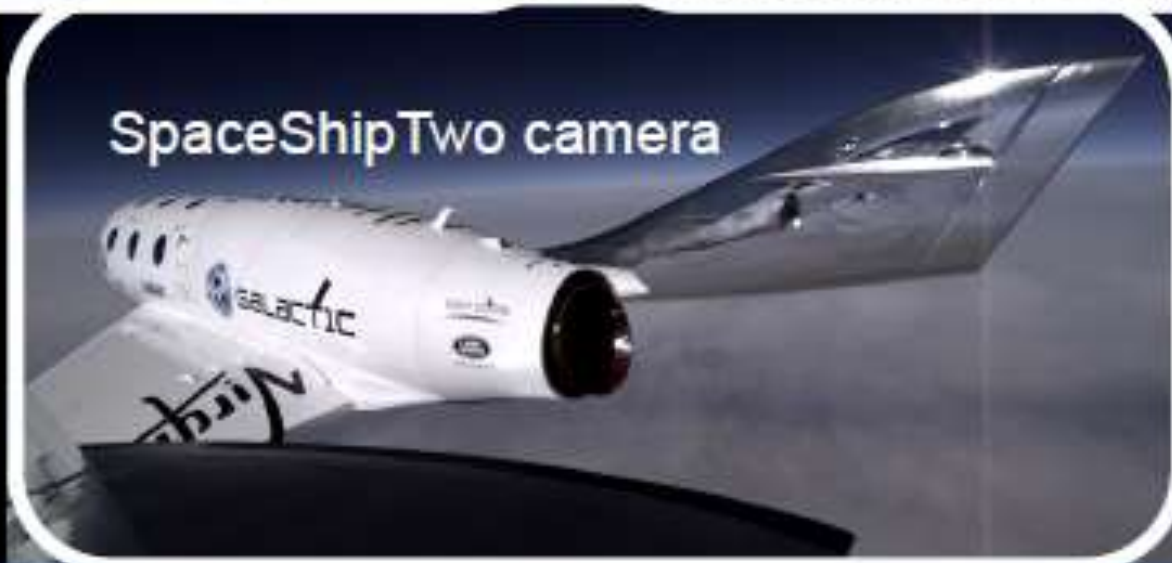
DCA15MA019
SCALED COMPOSITES
SPACESHIP TWO
N339SS
POWERED FLIGHT #4

- “Scaled Composites’ failure to consider and protect against the possibility that a single human error could result in a catastrophic hazard to the SpaceShipTwo vehicle.
- This failure set the stage for the copilot’s premature unlocking of the feather system as a result of time pressure and vibration and loads that he had not recently experienced, which led to uncommanded feather extension and the subsequent aerodynamic overload and in-flight breakup of the vehicle.”
